Kootenai Development Corporation

Flyway Property

Final Completion of Work Report

December 2004

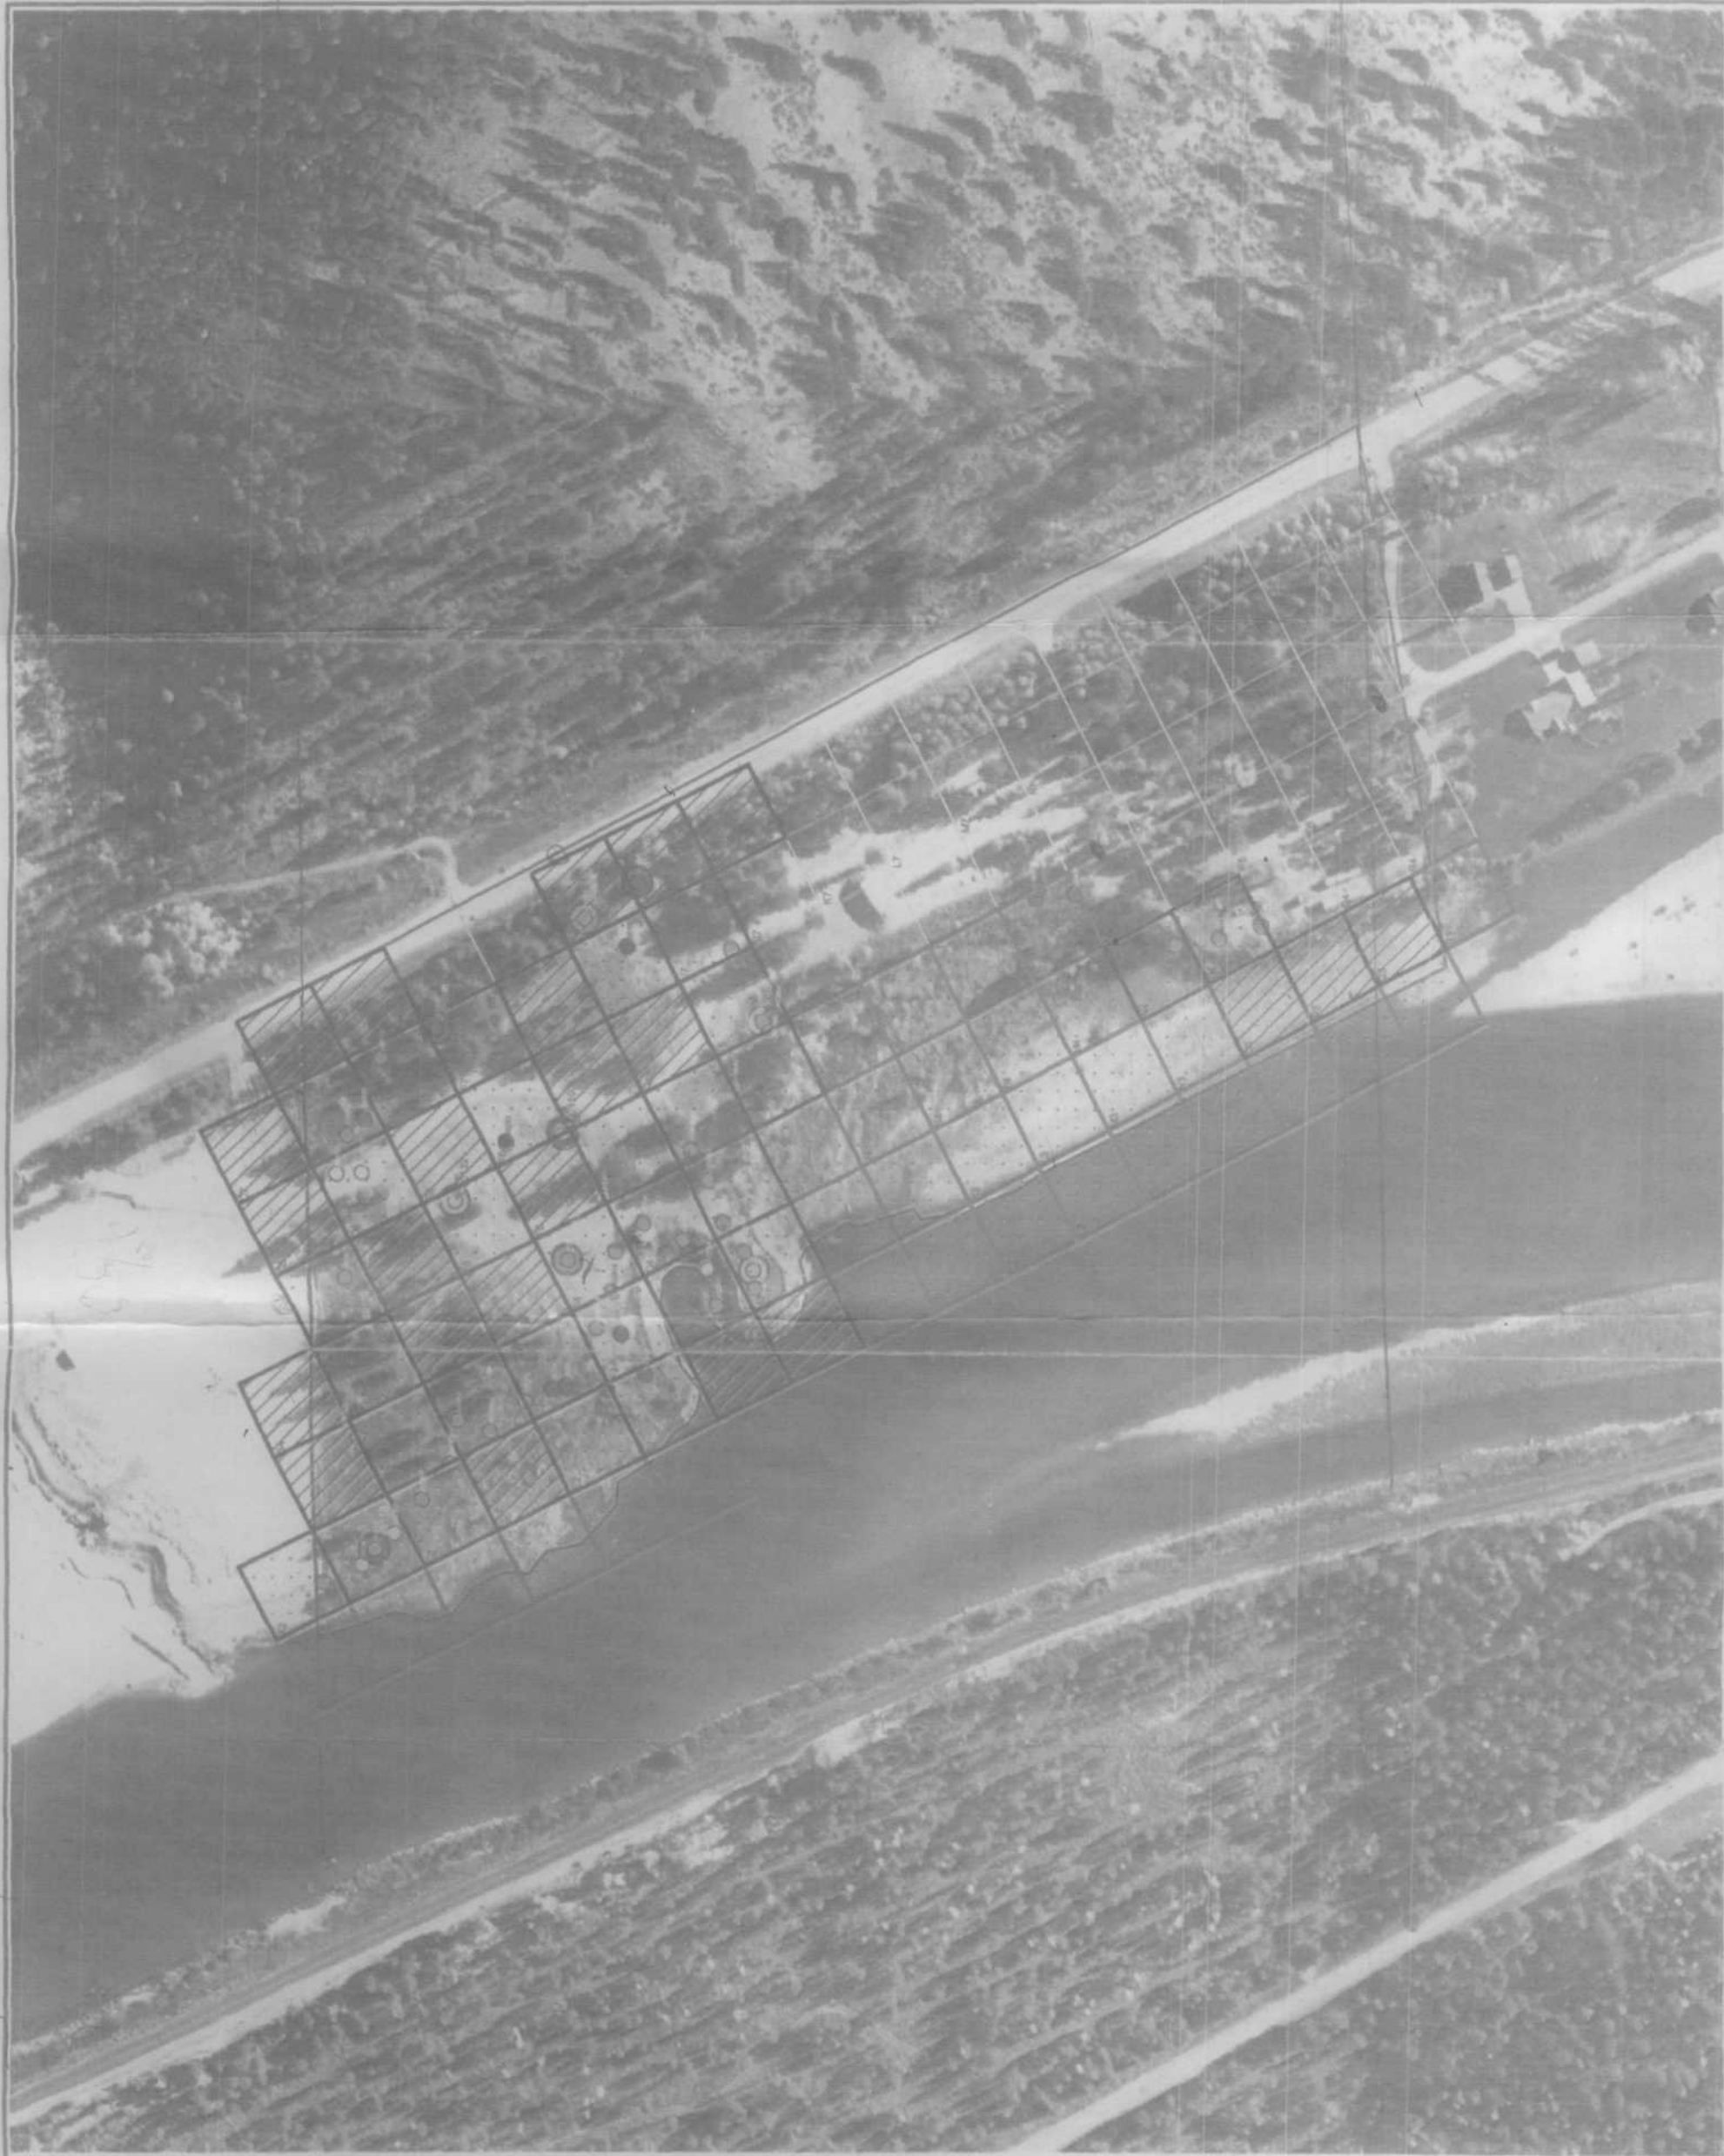
Characterization of the site was completed by EPA and the results, both surface and at depth, were included on the attached CDM Figure A2-2. This included grids with visible ^{rephrased} vermiculite only. Remedium (W. R. Grace & Co.) did not perform any additional sampling for delineation purposes. Figure A2-2 became the basis for the planned 2003 removal action by USEPA. No removal or restoration activity was conducted on the site by USEPA in either 2002 or 2003.

KDC Flyway Property
2003 Pre-Removal Soil
Results and Sampling Grids

The EPA Remedial Action Work Plan Addendum 1 (May 10, 2002) and Addendum 2 (July 18, 2003) designated that 53 grids (each 100' x 100') be remediated on this property. However, 5 of these grids lay on U.S. Highway 37 right-of-way and were not part of the Grace property. W. R. Grace & Co. is in Chapter 11 bankruptcy proceedings and is not permitted to remediate non-owned property. As a result, it was jointly agreed that USEPA would remediate the 5 grids along Highway 37 right-of-way and Grace would remediate the remaining 48 impacted grids. During the late stages of remediation, two additional contaminated grids (J5 and J6) were observed during the excavation of grid I-5. Although these two grids were not in the original scope of work, excavation continued until all impacted soil was removed. As a result, 50 grids were remediated.

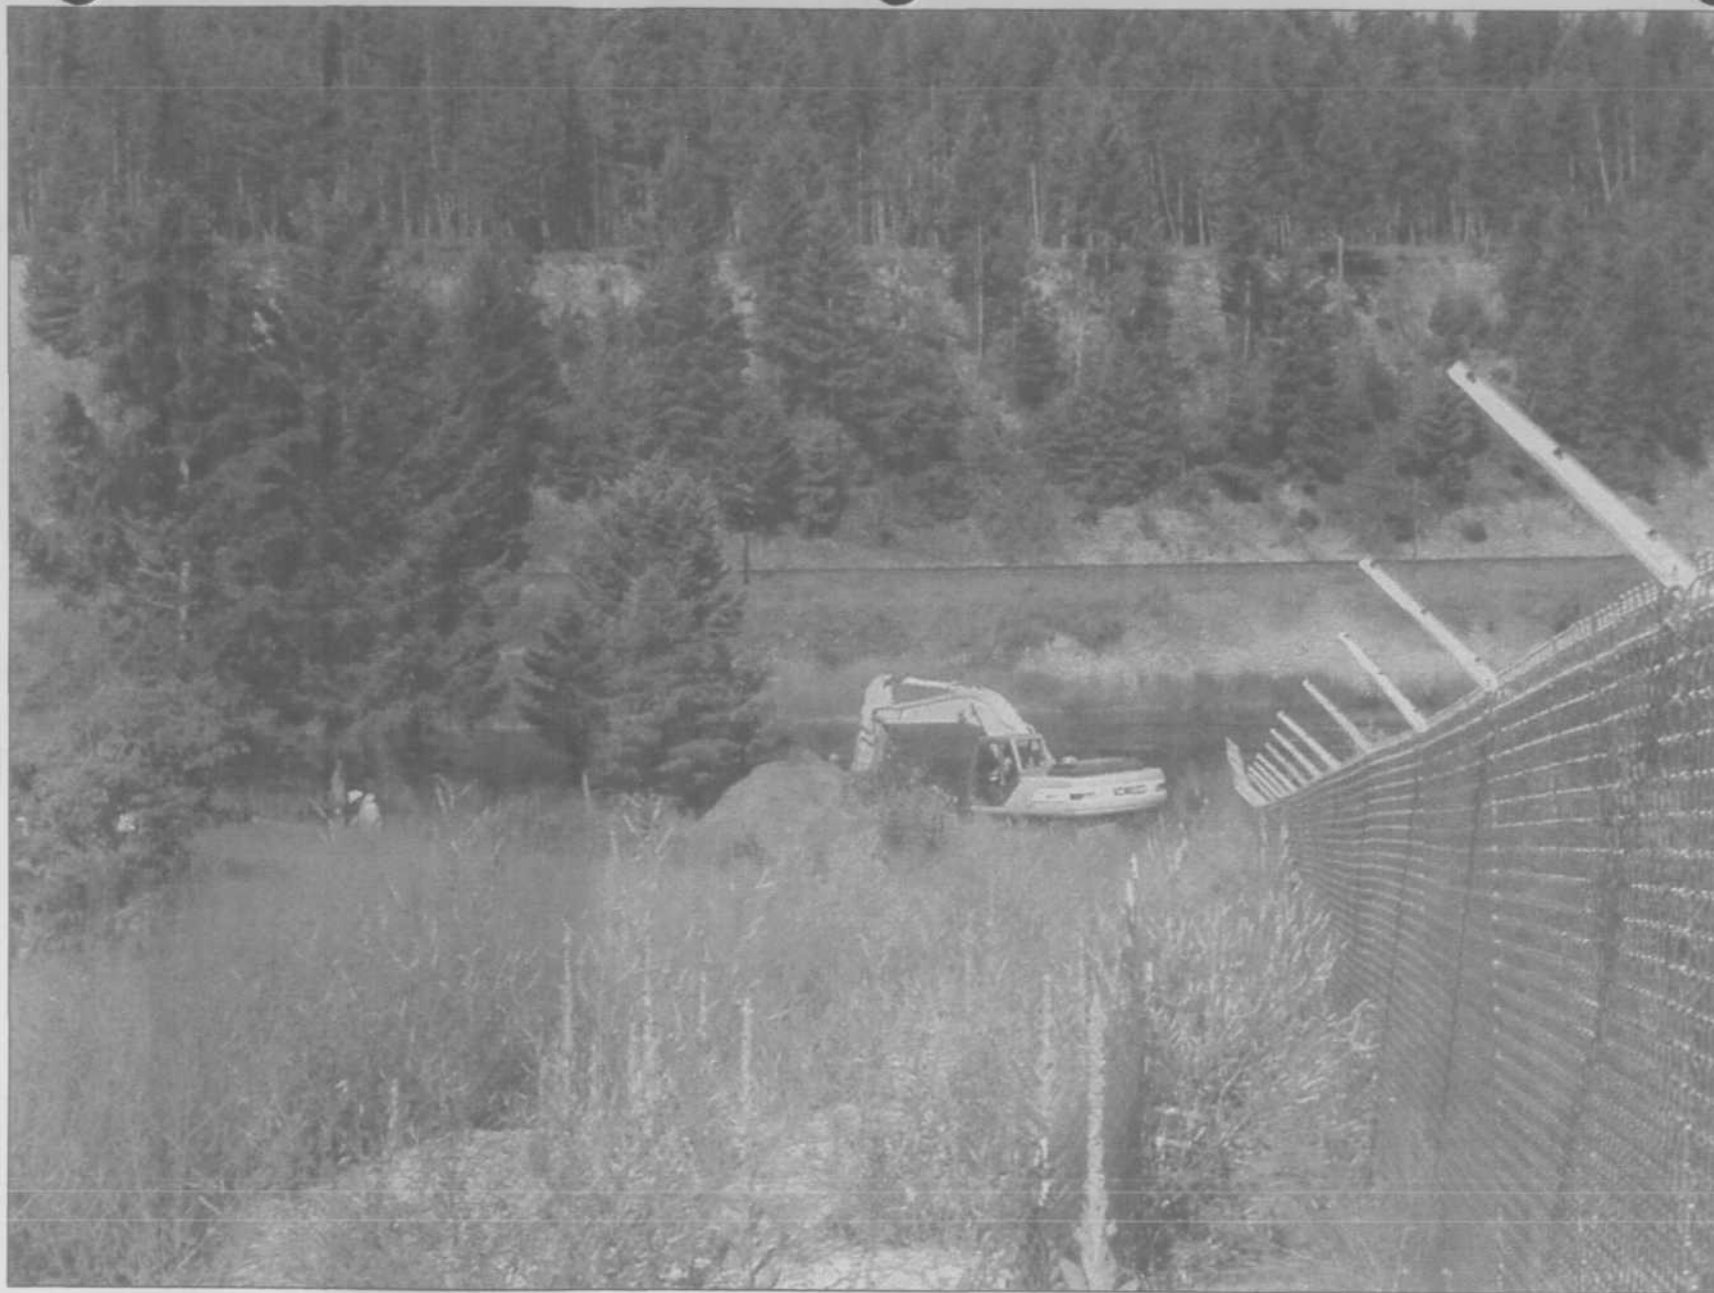
Flyway Site - Start of Excavation

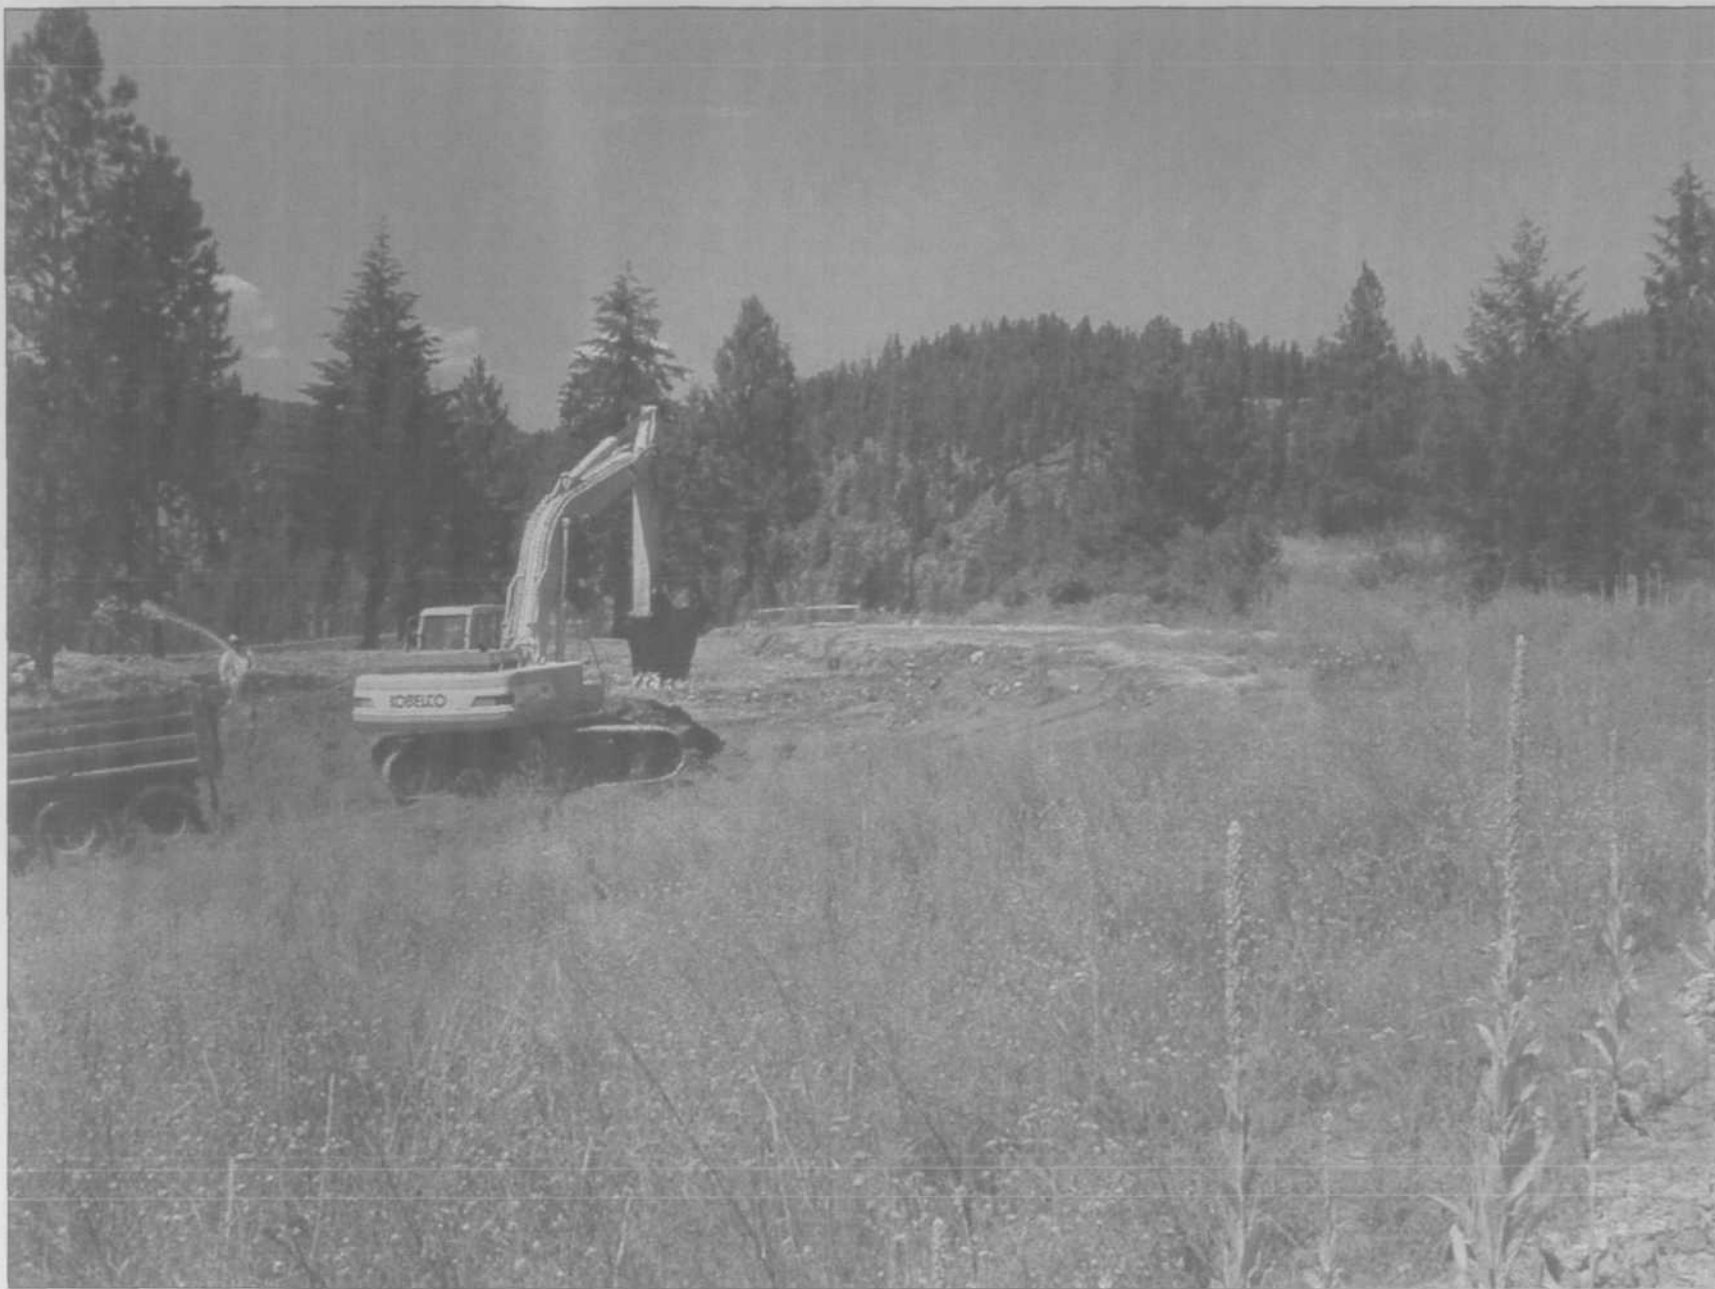
Flyway Site - Typical Excavation

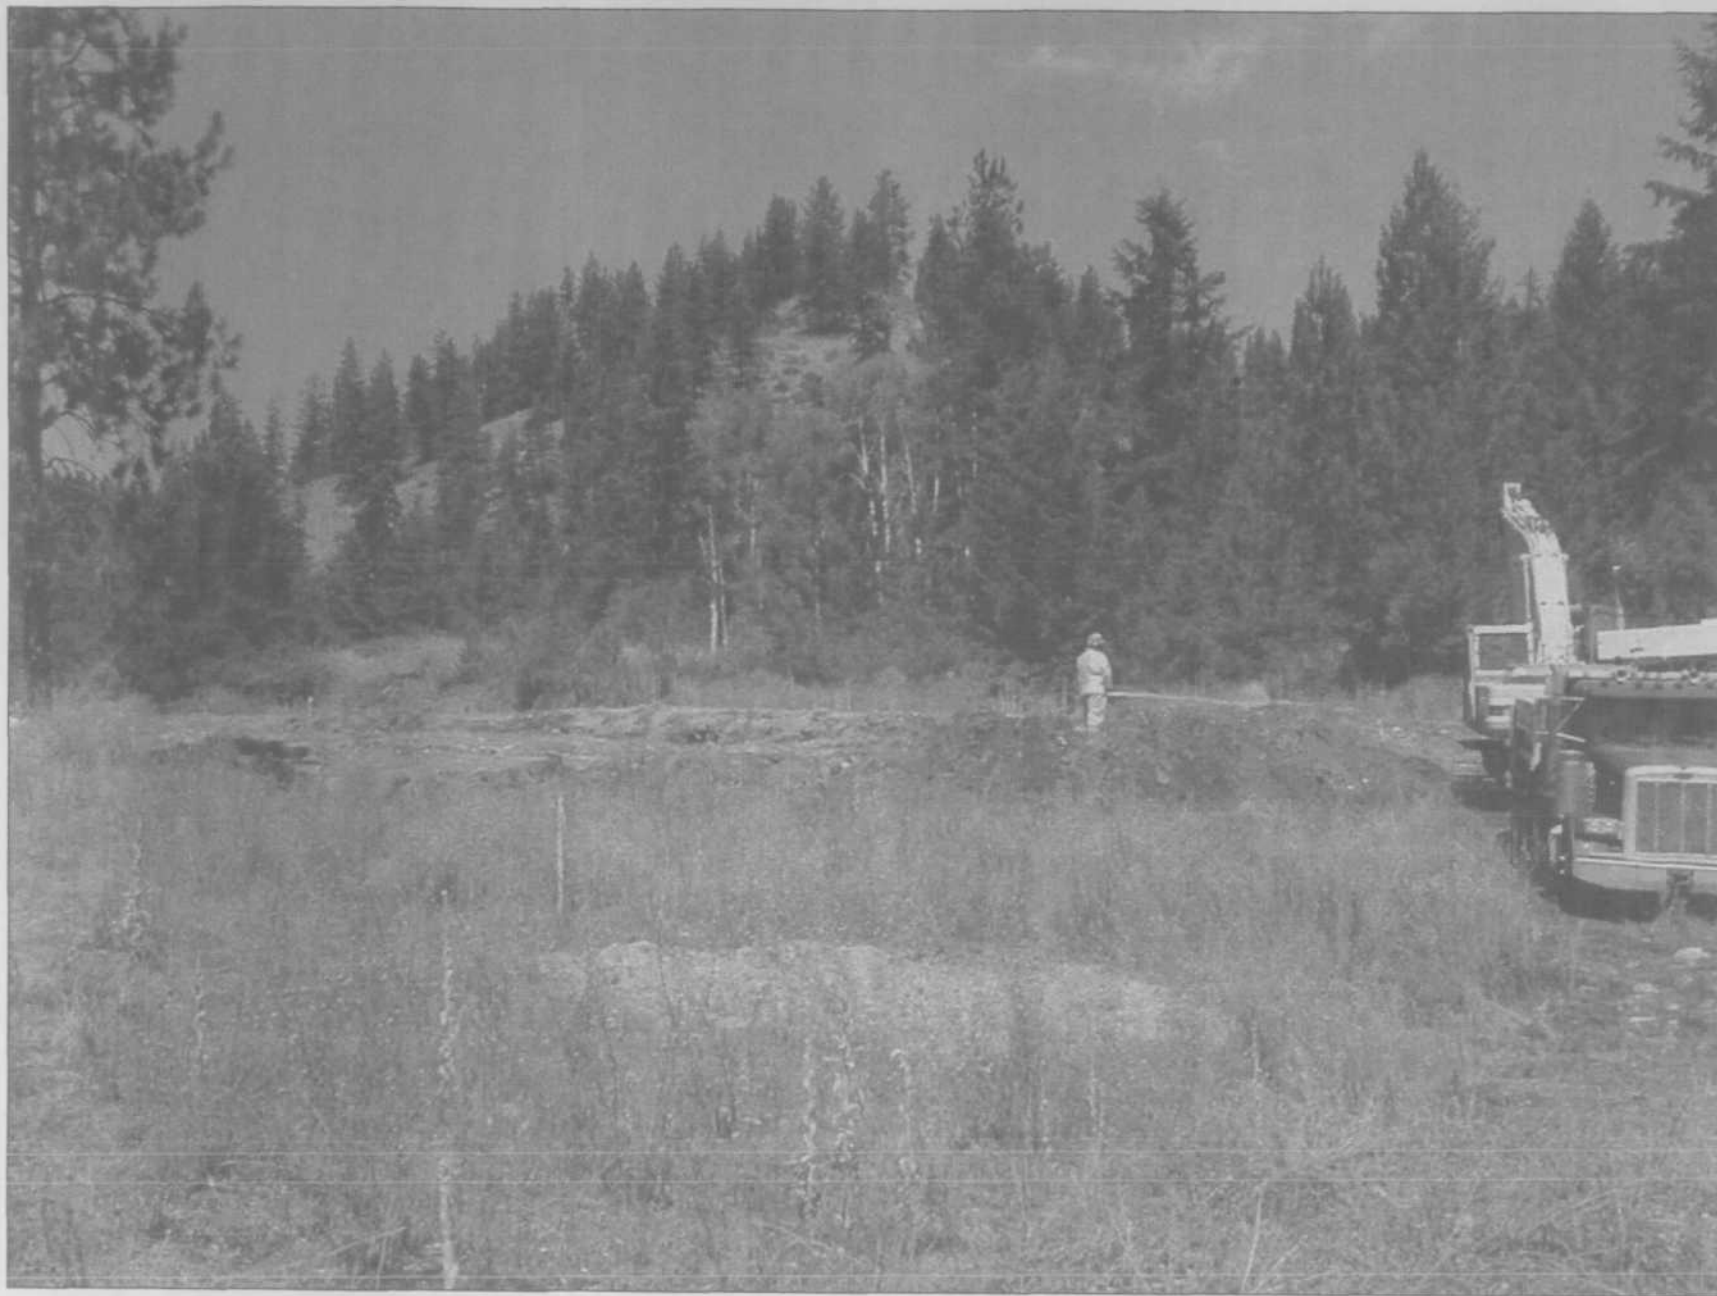
Flyway Site - Excavation and Water Hose Application

As soil was excavated and loaded, a laborer was nearby with a fire hose equipped with a spray nozzle to control dust during dry weather conditions. All personnel in the site work zone, trucks, and mine disposal areas were dressed in Level C at all times and wore, at a minimum, full-face respirators.

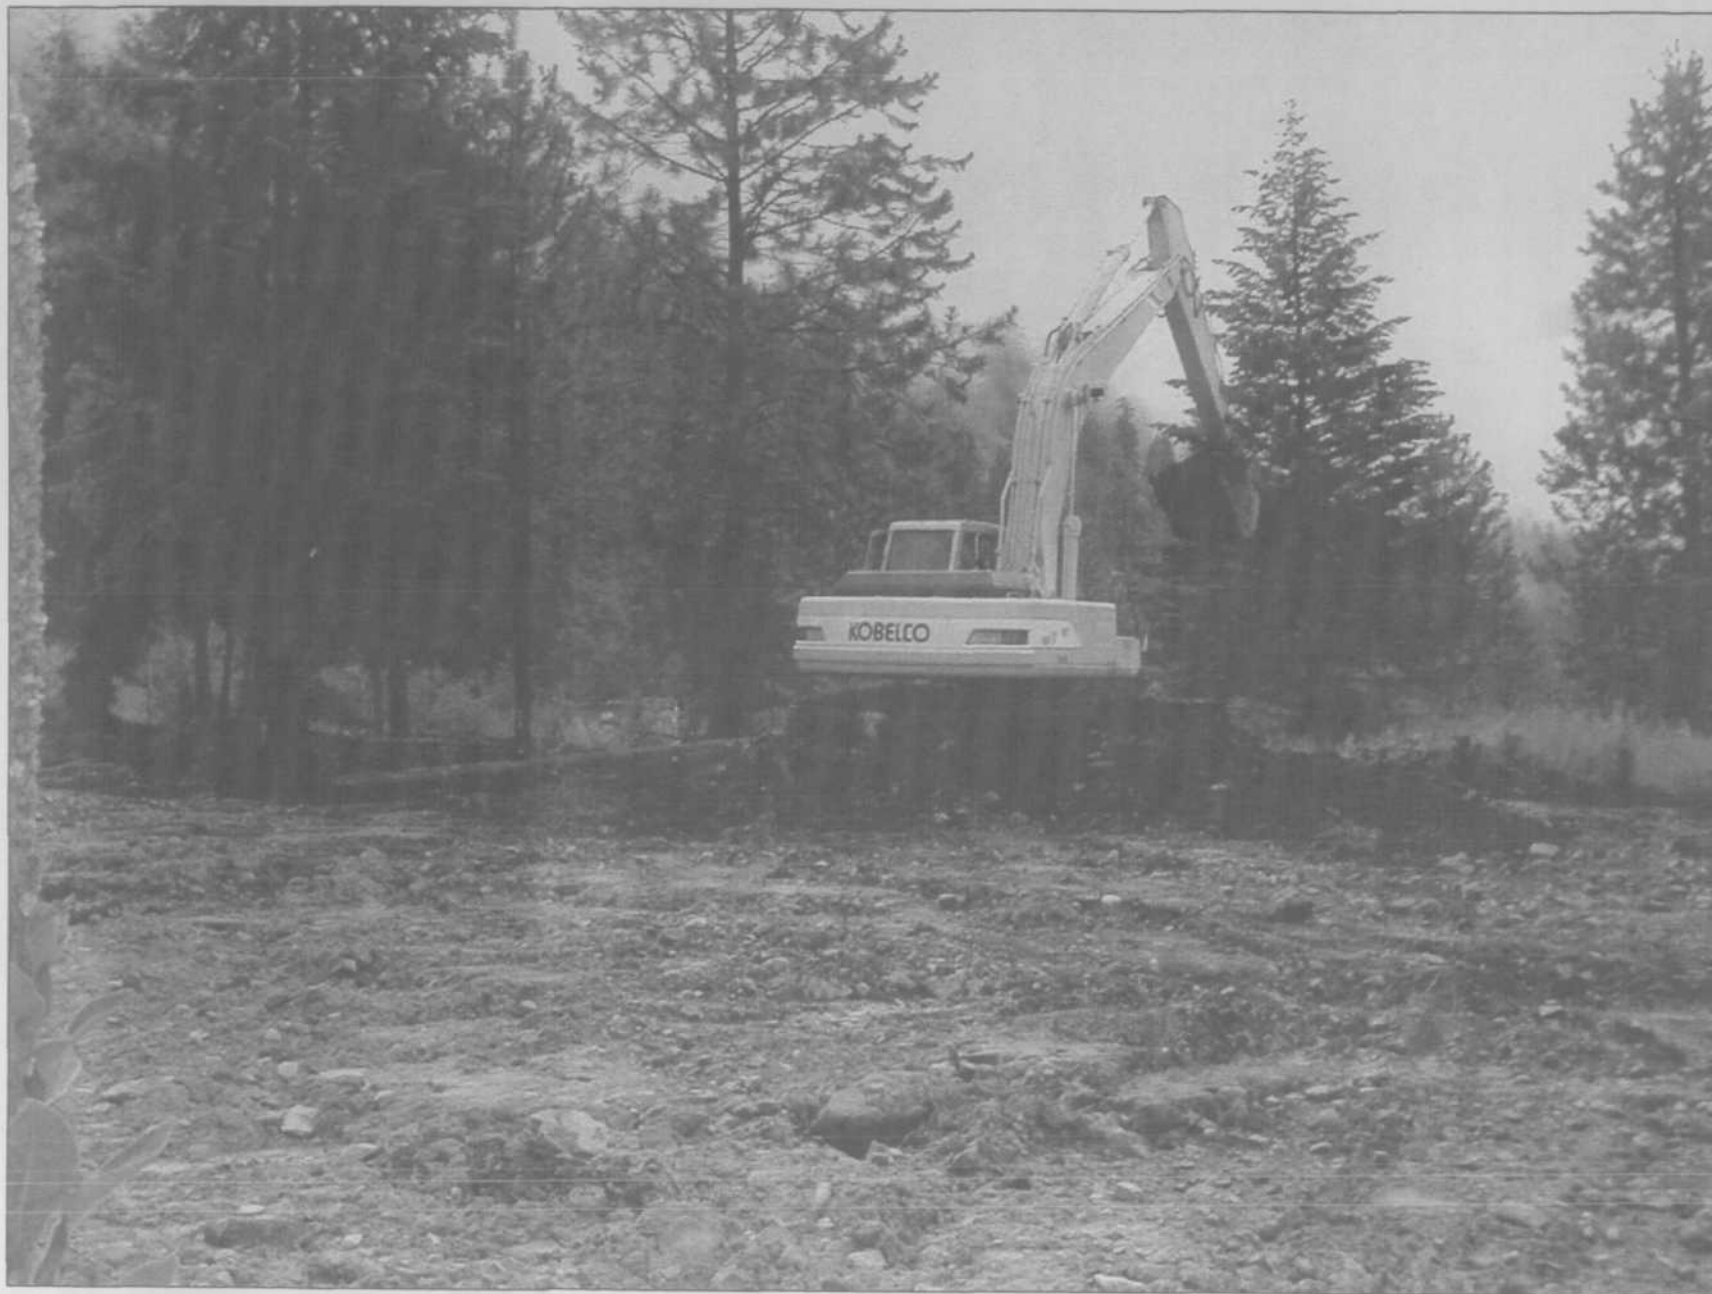
Flyway Site - Excavation Activity

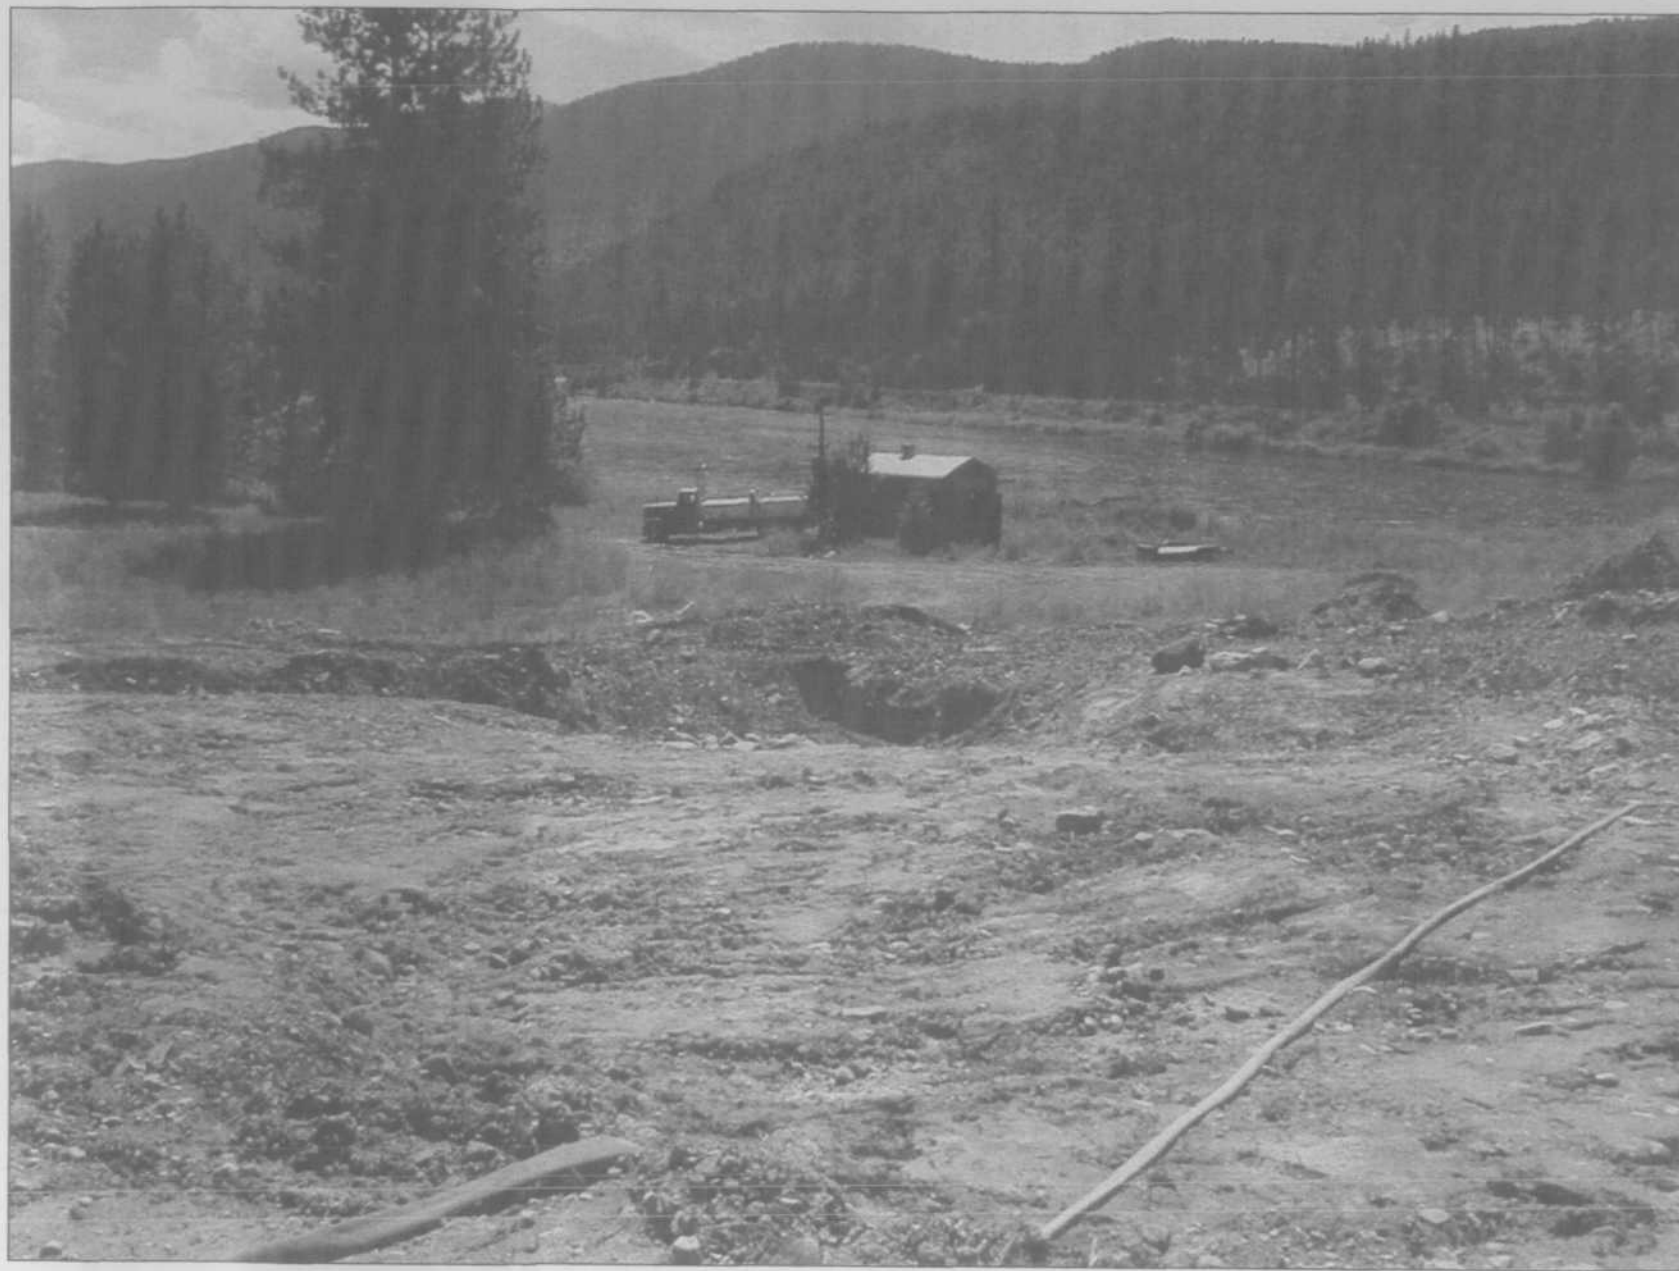
Flyway Site - Continued Excavation

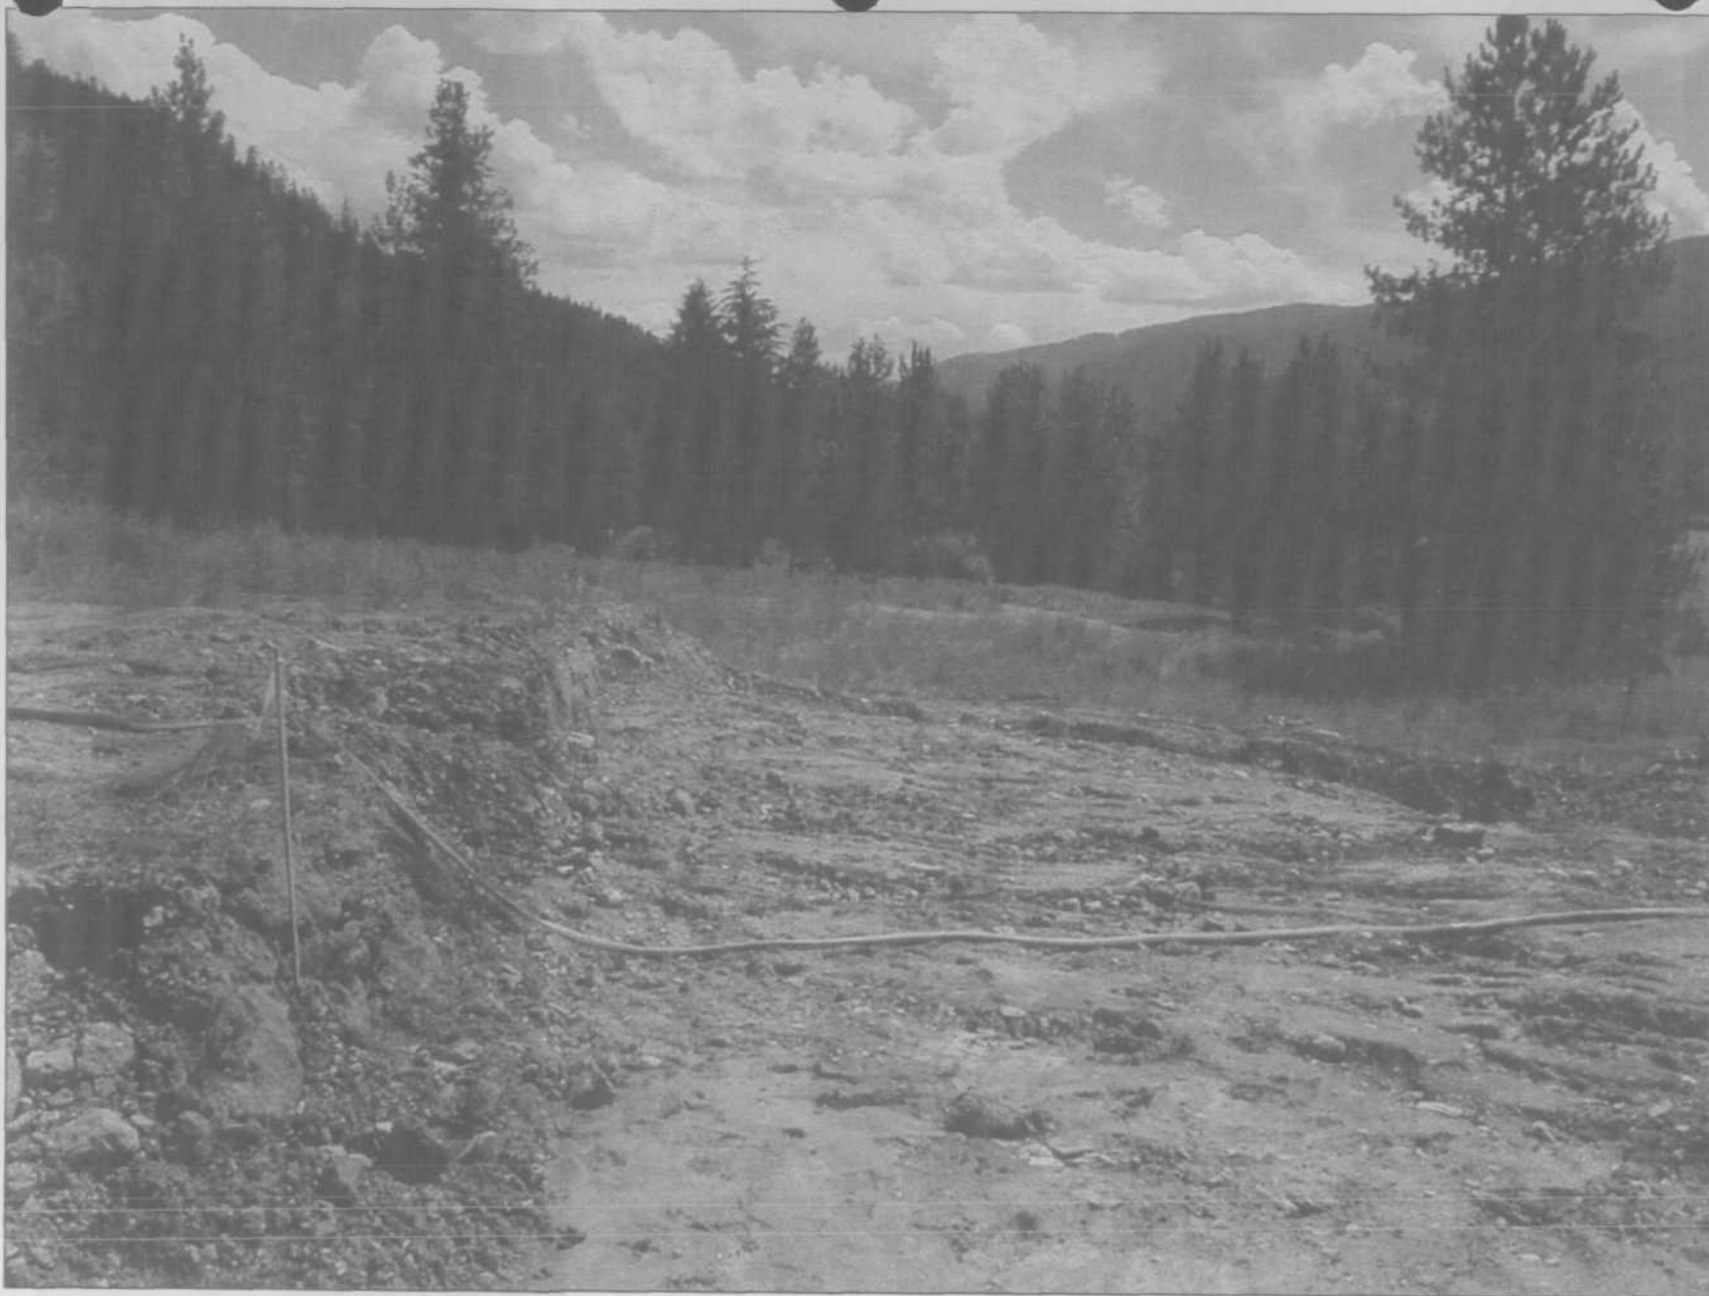
Flyway Site - Deeper Excavation

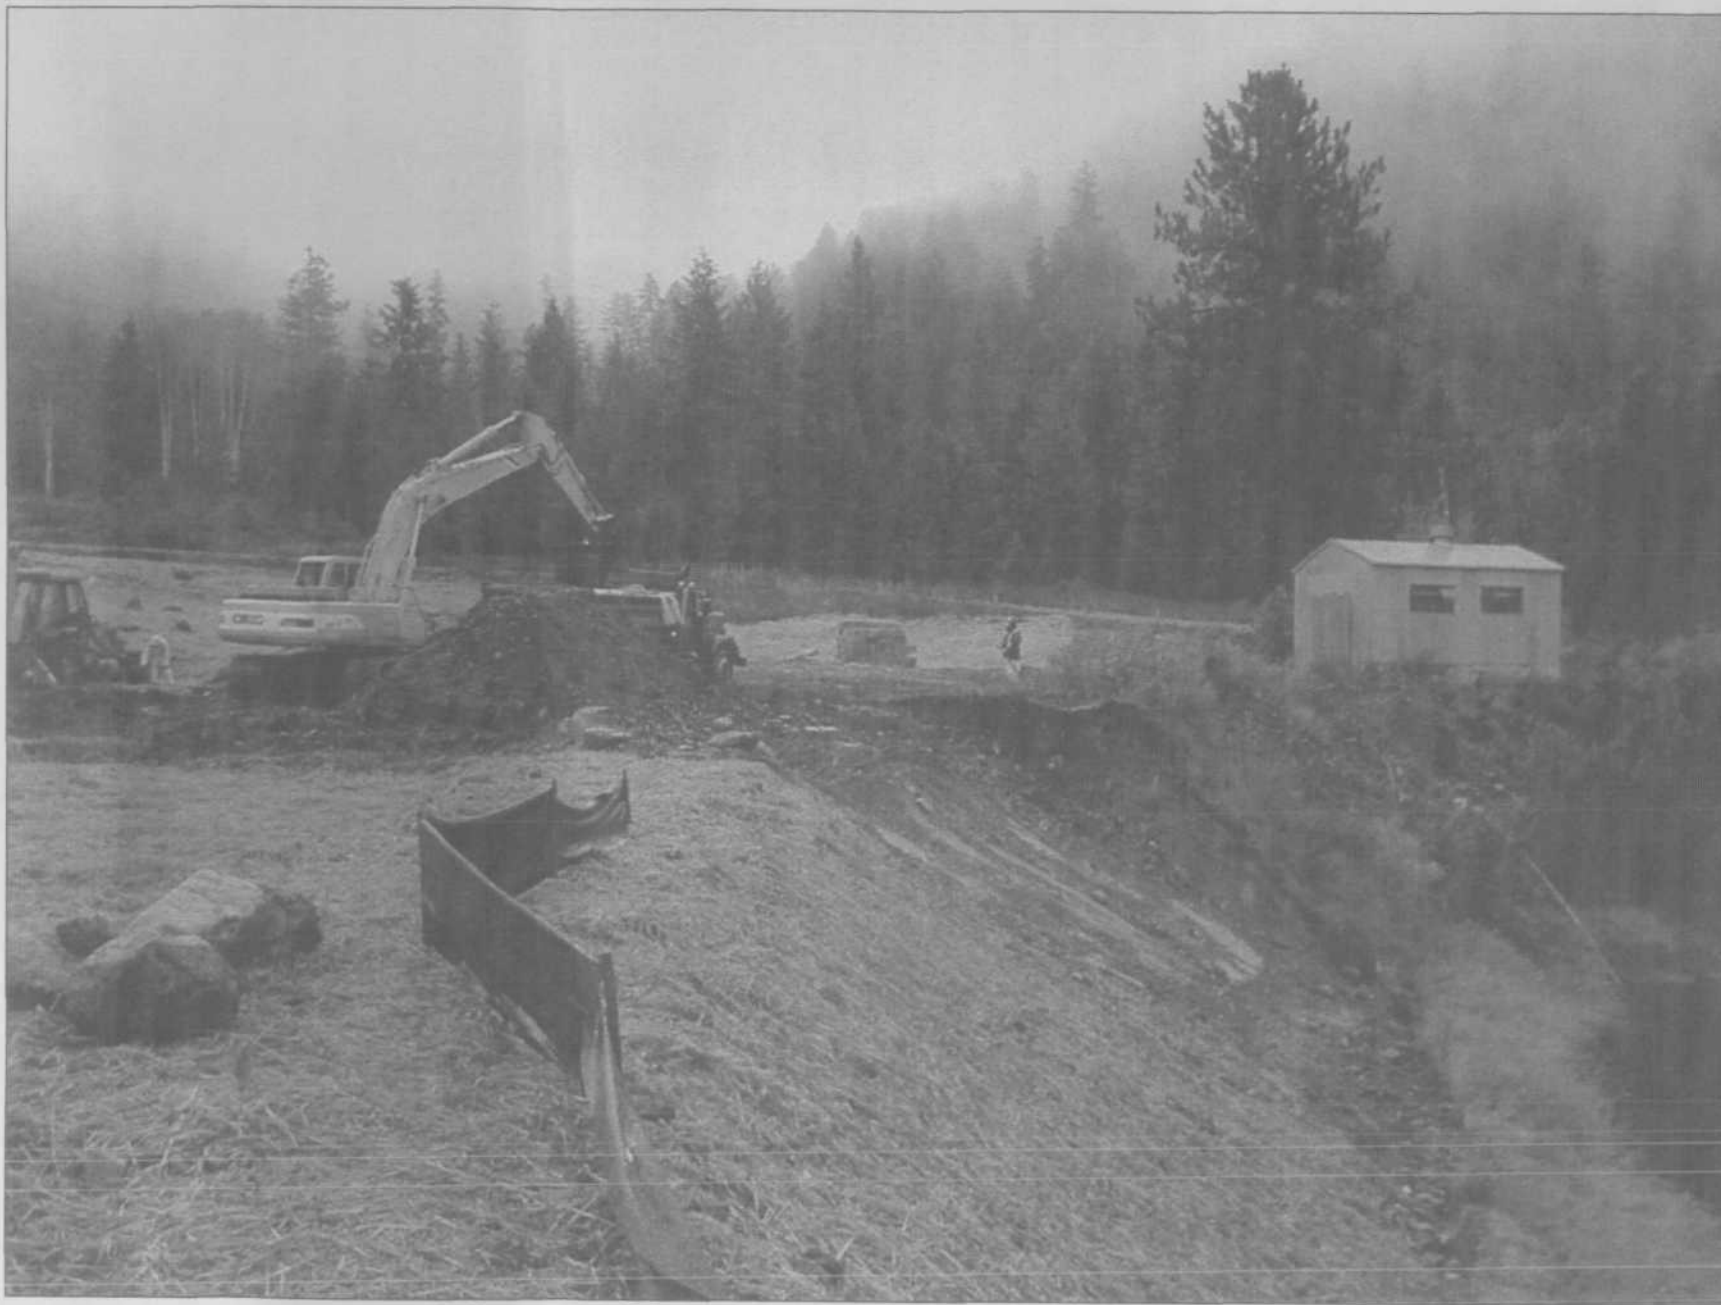
Flyway Site - River Bank Excavation

After the site was backfilled and graded, the riverbank slope was stabilized by placing silt fence and straw bales at the top of the slope. Additionally, rock that was collected from the site was placed along the river's edge. The rock (riprap) extended 4 feet below high water mark and 2 feet above. The extent of riprap placement was approved by EPA.

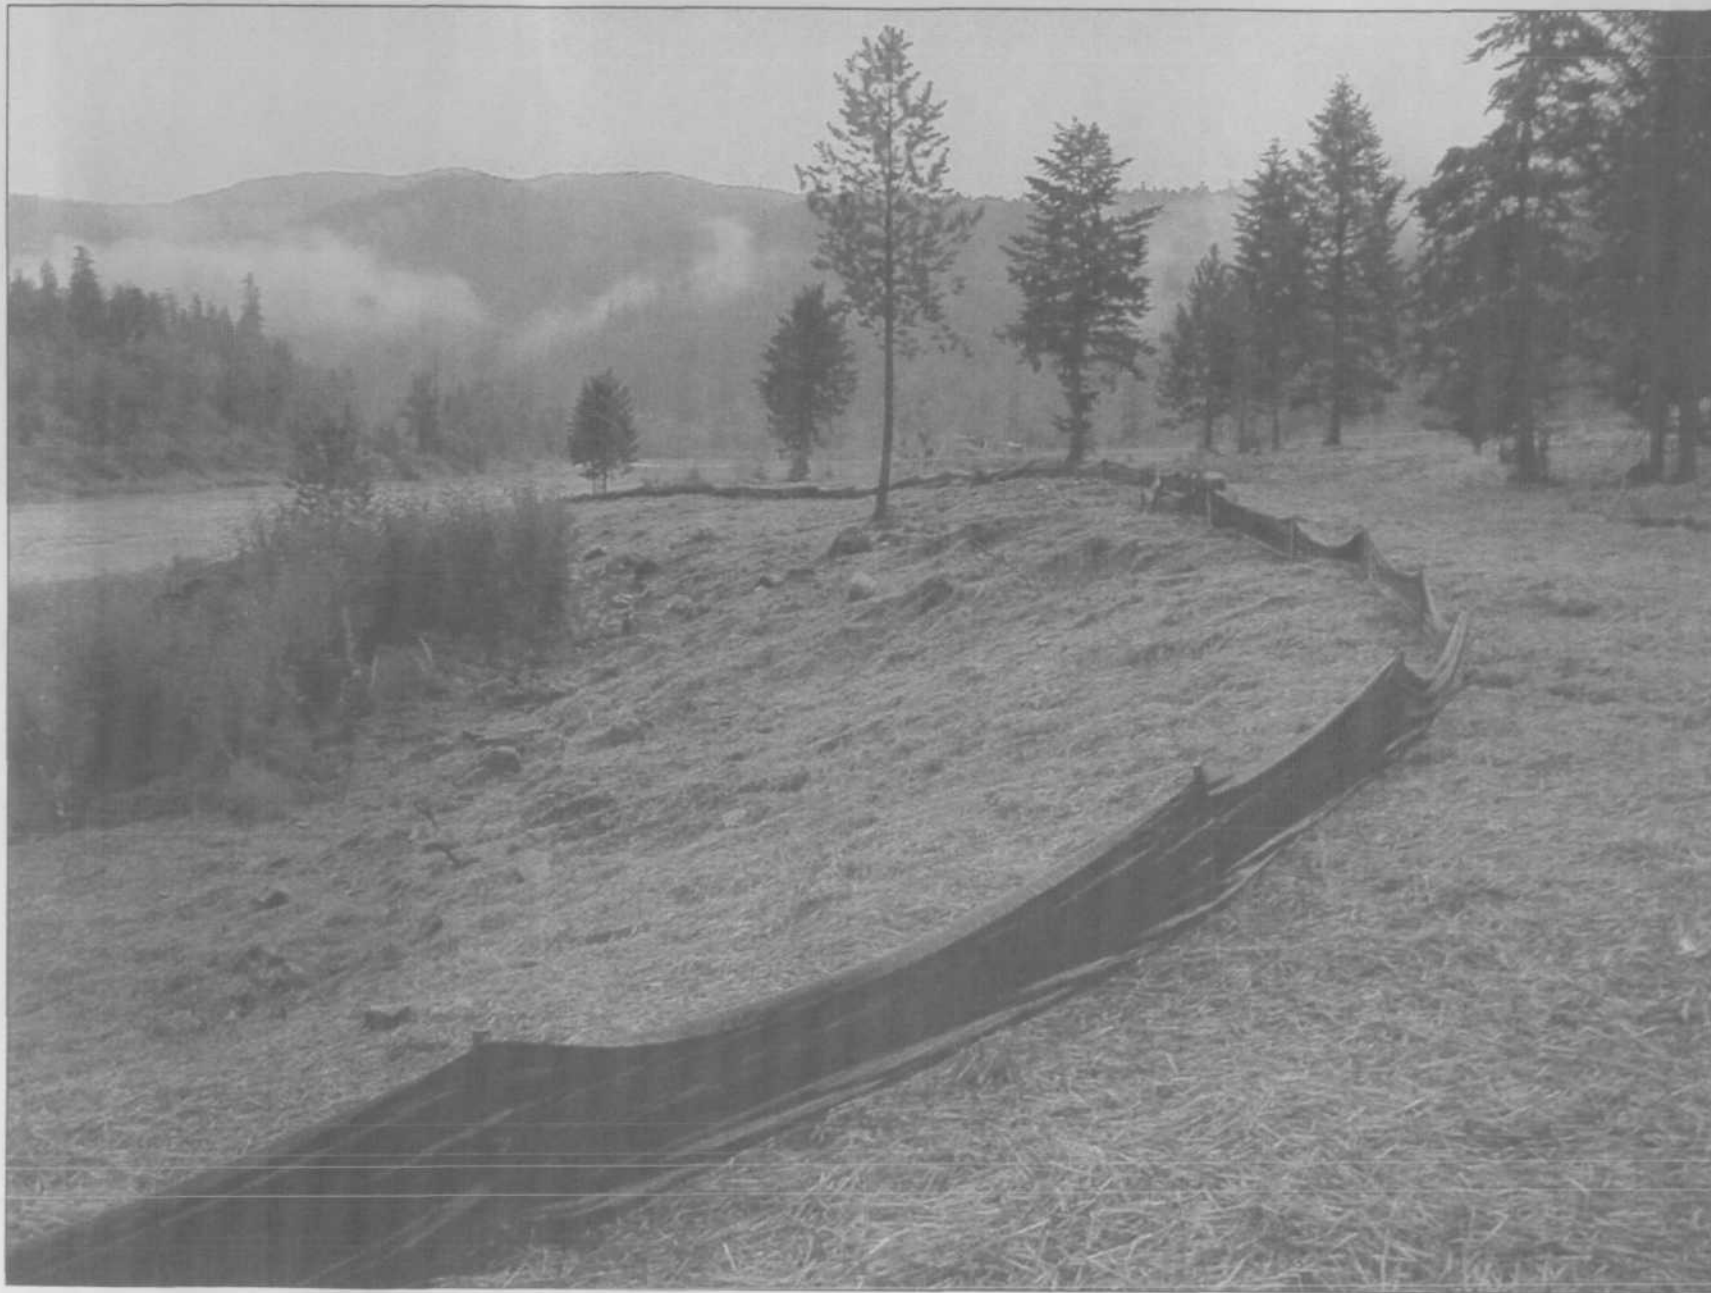
Flyway Site - Excavated Area with Straw Applied
